NASA Technical Memorandum 113128

Hot Corrosion of Single-Crystal NiAl-X Alloys

James A. Nesbitt
Lewis Research Center, Cleveland, Ohio

May 1998

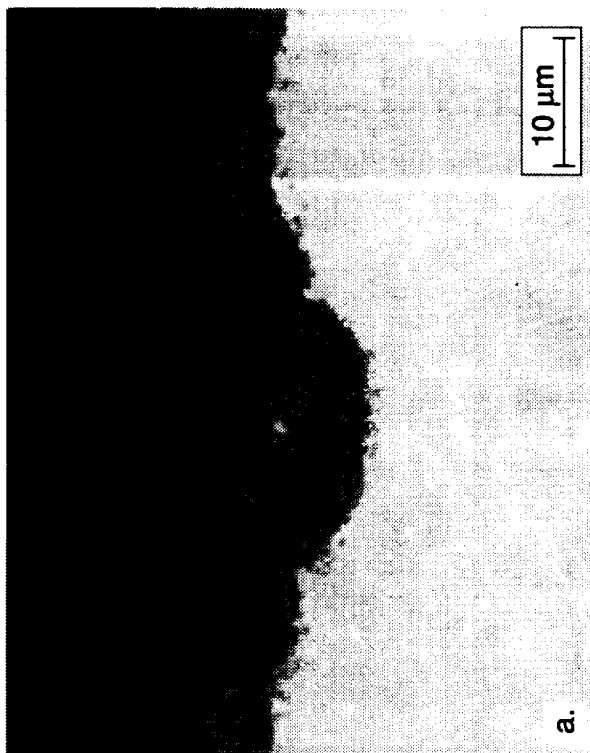
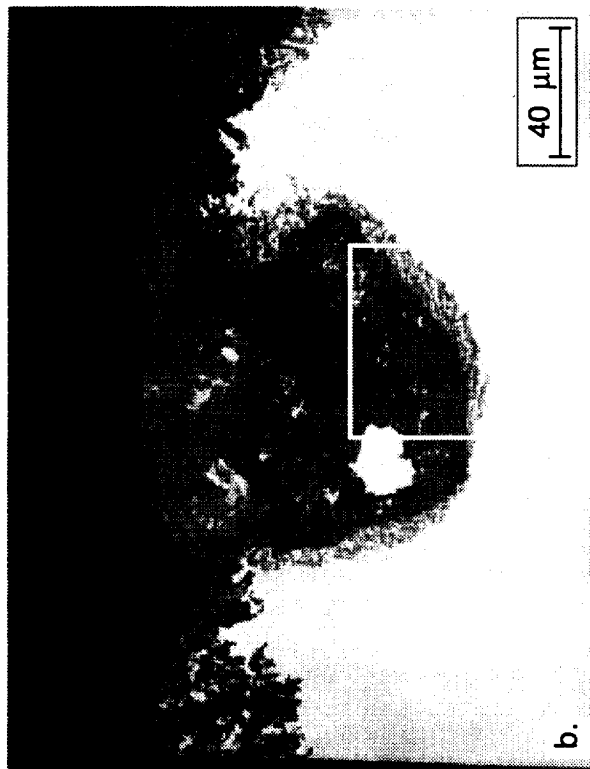
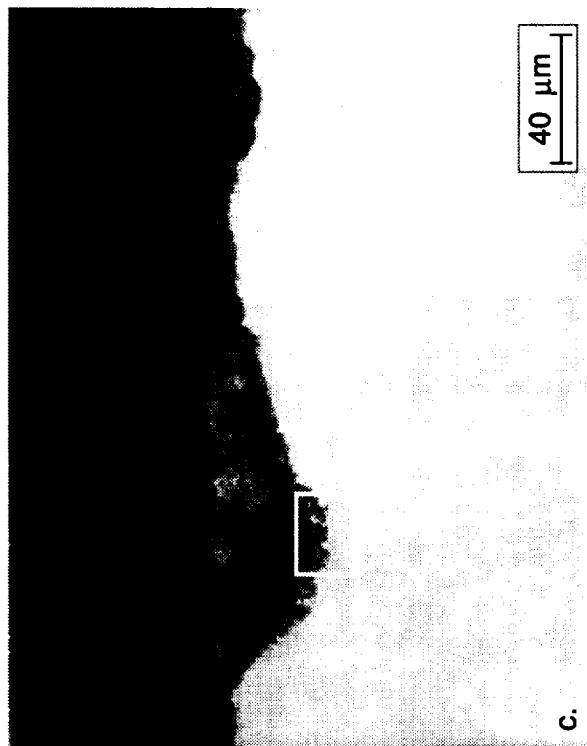
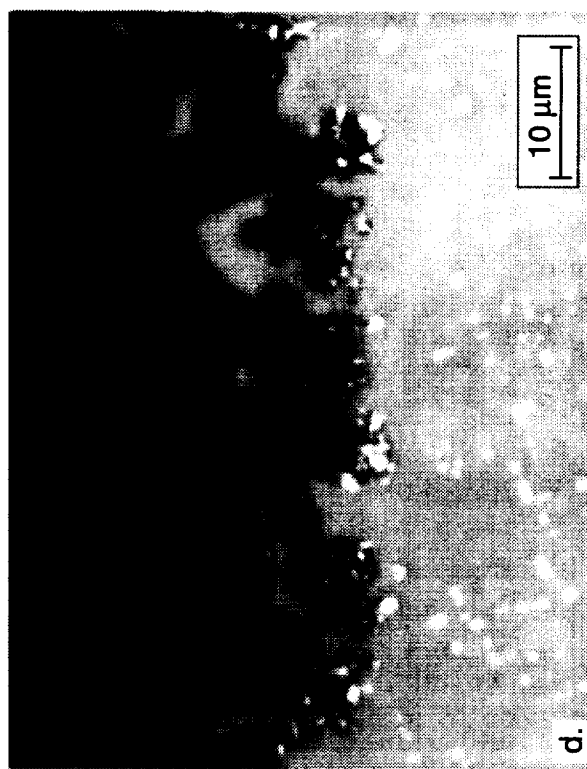
Fig. 97 Intermediate attack in AFN20. Image (d) is a higher magnification of the box shown in (c).

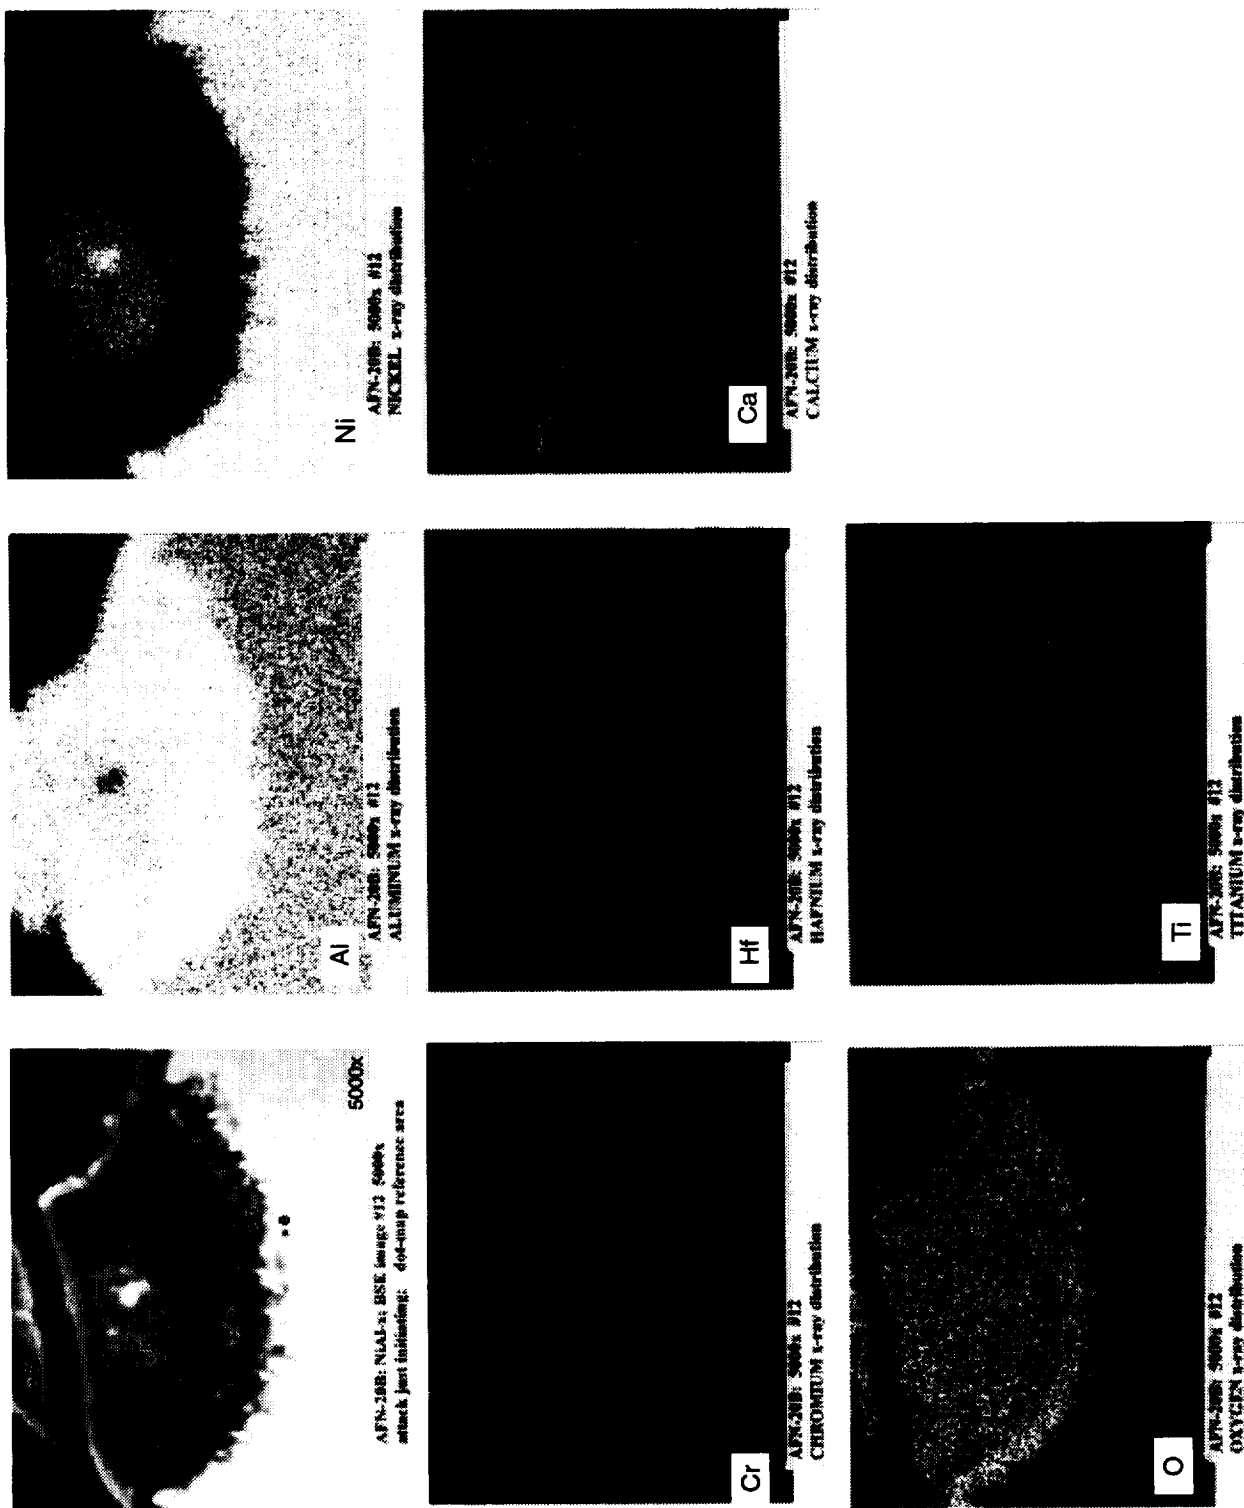
Fig. 98 X-ray maps of intermediate attack in AFN20 shown in Fig. 95d.

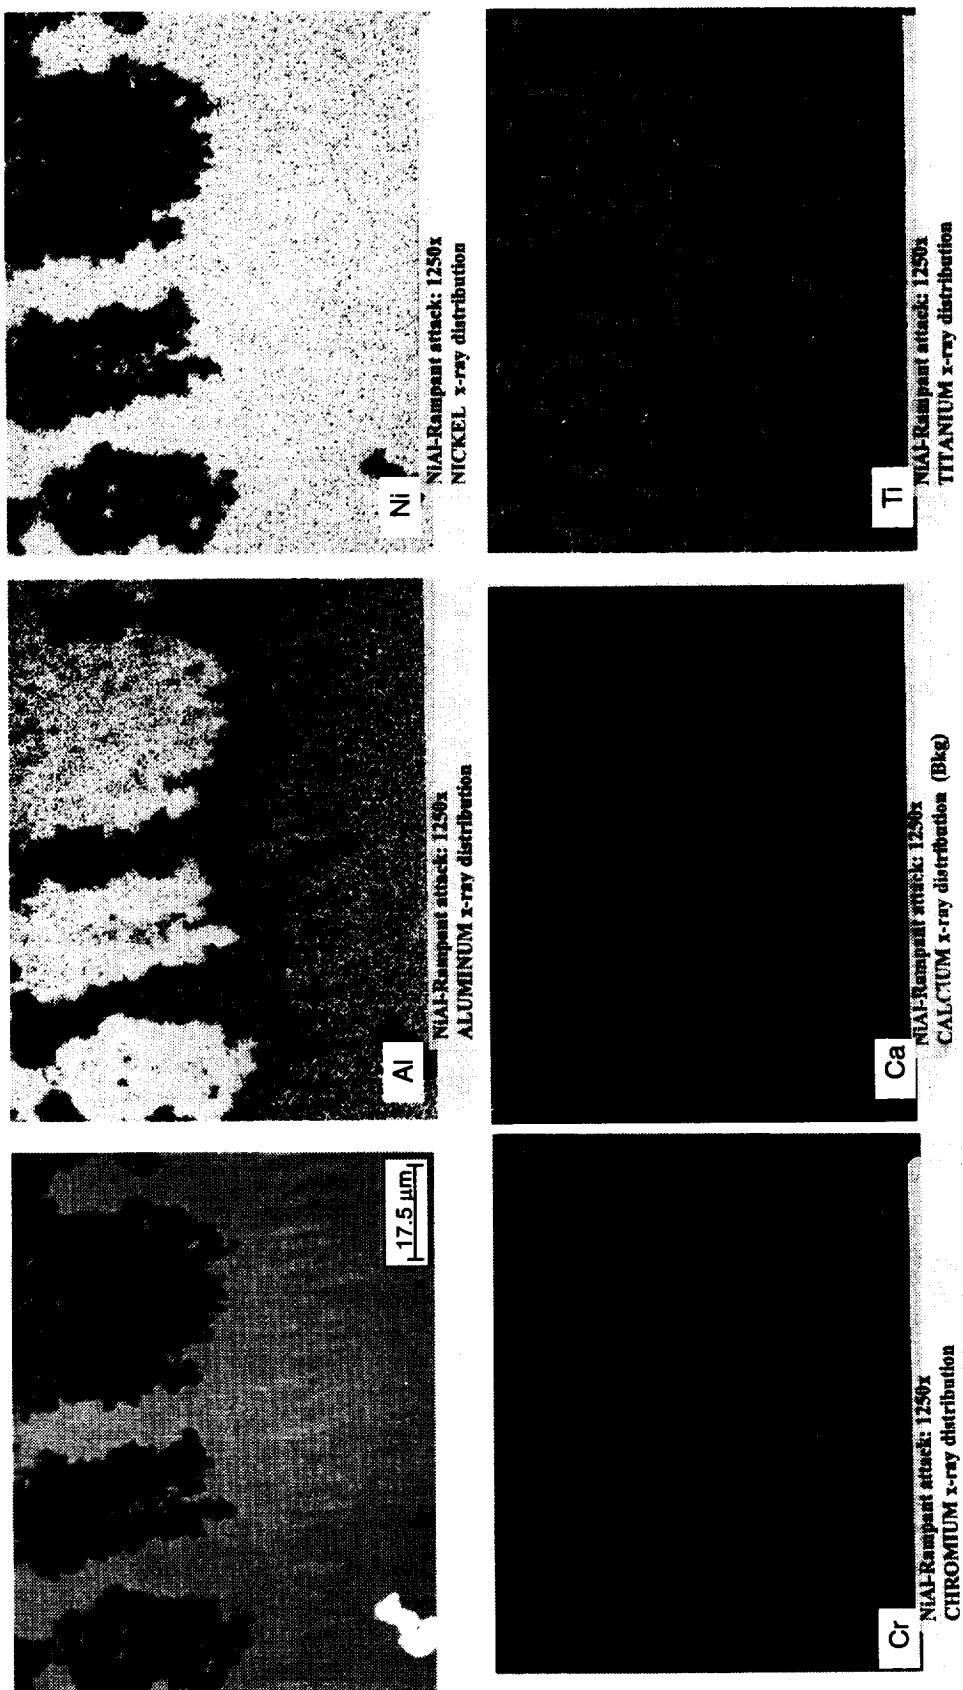
striations are also evident in much of the oxide in this figure. Elemental distributions in the region of Fig 101d is shown in the x-ray maps in Fig 102. The striated oxide is primarily Al and Ti with a small presence of Cr. Regions of γ and γ' can be distinguished from the Al map. Not surprising, the Ti partitions to the feathery γ' below the oxide phase. It is significant that there appears to be no enrichment of Ca, Si or Na in the x-ray maps of Fig 102.

Fig. 102 X-ray map of inner region of rampant attack shown in Fig. 101d (AFN19 after 300 hrs).

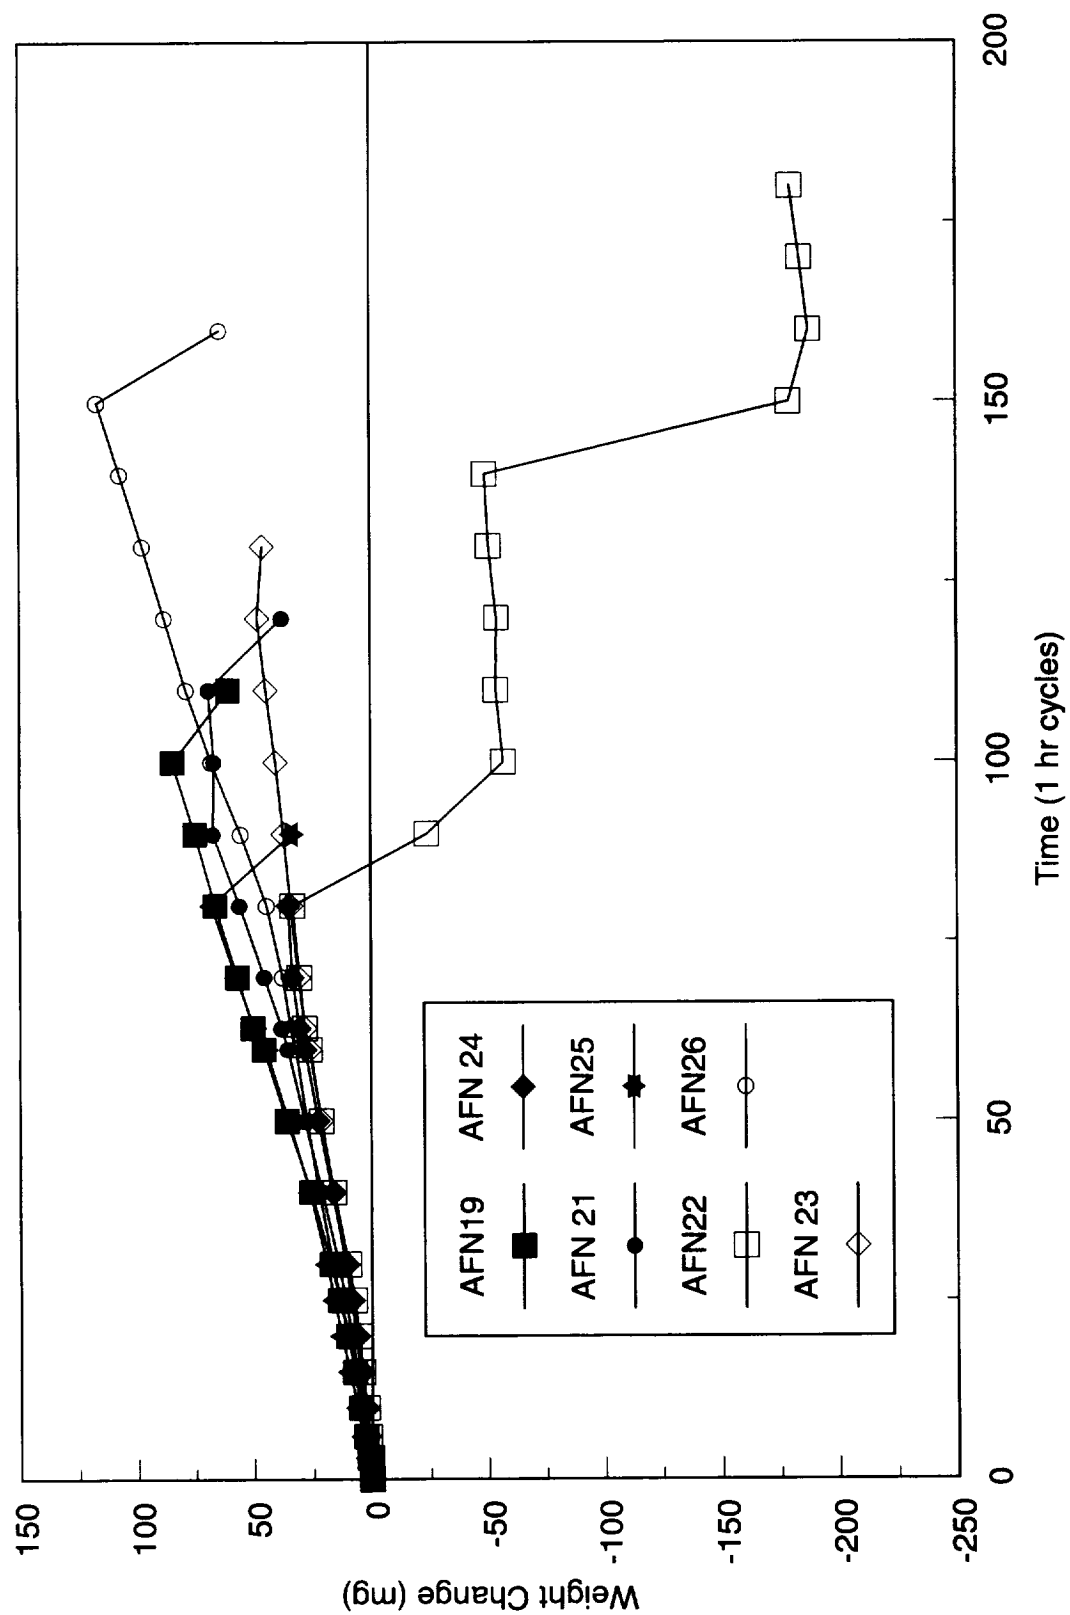
The weight change for the seven NiAl samples is shown in Fig 1. As previously stated, all of the samples gained weight more rapidly due to accelerated attack on the ID of the samples. The AFN24 sample fractured longitudinally into two halves between 70 and 80 hrs and was removed from the test. The weight losses of other samples after 80 hrs are due to smaller pieces of the sample fracturing off, but allowing the sample to continue being tested.

Appendix B Fig 1 Weight change during Series I, electropolished samples.

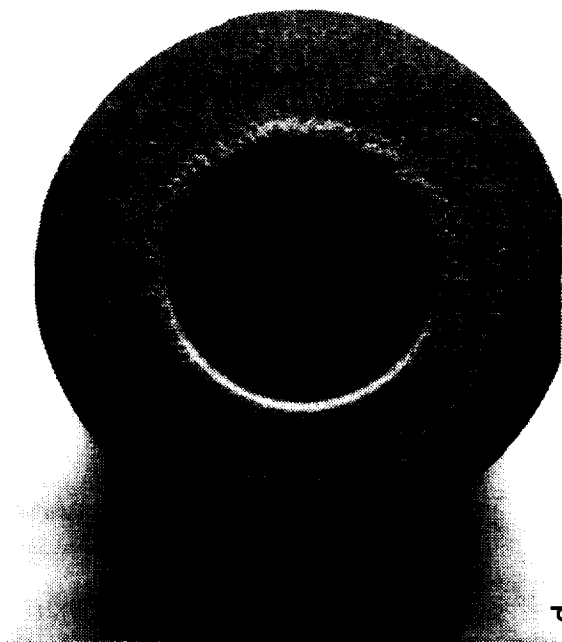
Appendix B Fig 4 Macrophotos of electropolished (a,b) AFN23, (c,d) AFN24 after 63 hrs.

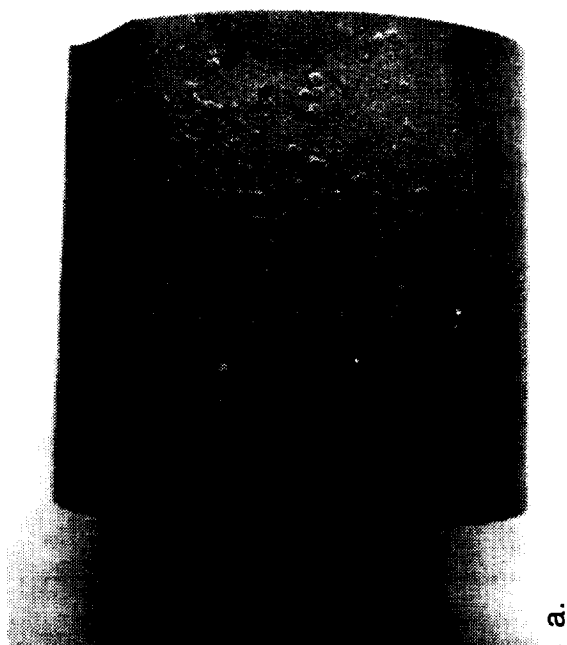
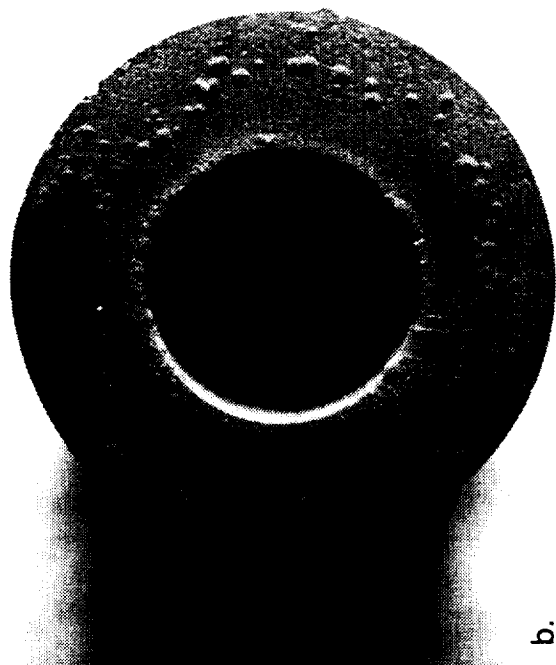
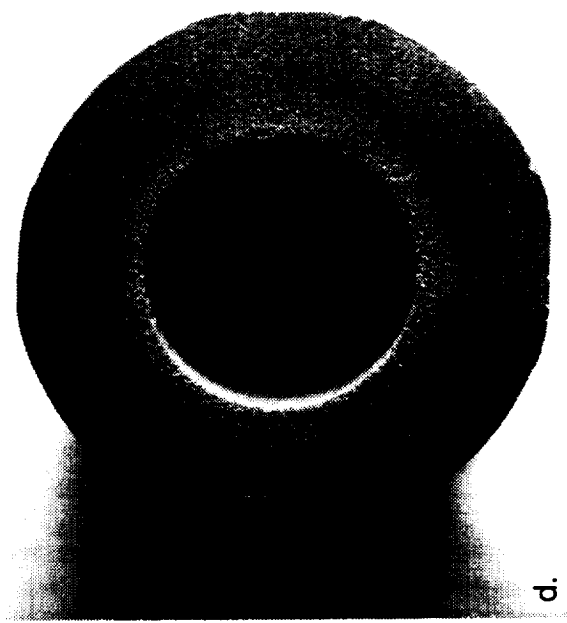
Appendix B Fig 5 Macrophotos of electropolished (a,b) AFN25, (c,d) AFN26 after 63 hrs.
